# **Annual Inspection**

**Croston Parish Council**

Croston Rec Play & Gym Areas

Inspected: 12-March-2025 - 09:17 by Michael Allbright

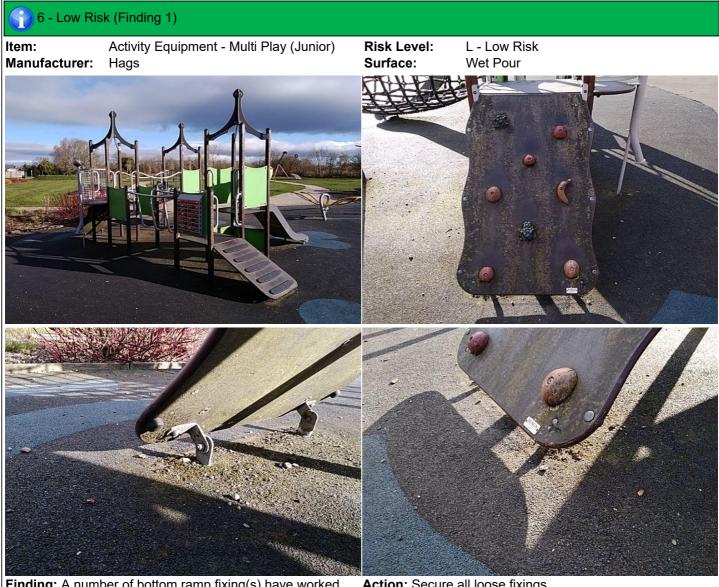
**Finding:** A number of bottom ramp fixing(s) have worked **Action:** Secure all loose fixings loose

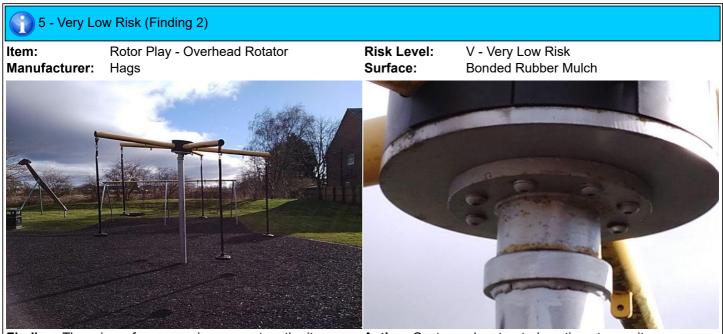
Finding: There is surface corrosion present on the item

Action: Customer has treated continue to monitor

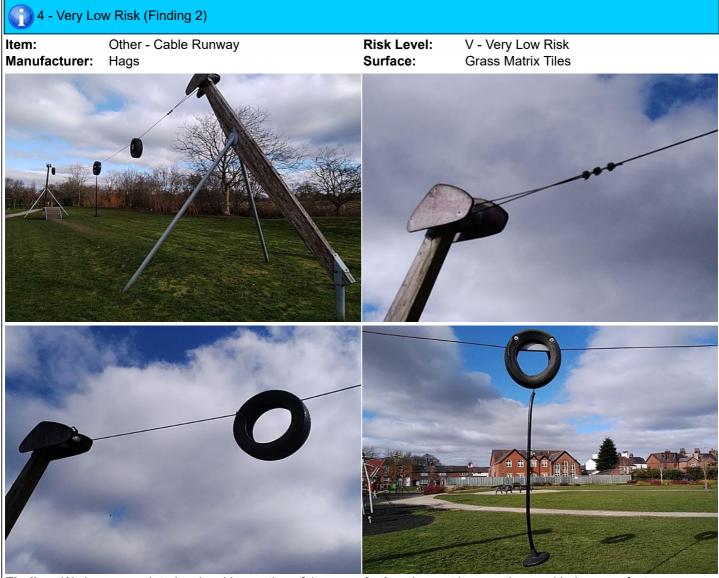
**Finding:** We have completed a visual inspection of the cable and fixing points from ground level, however it is not possible to fully inspect the cable and fixings without either hiring equipment to gain access or removing the cable and inspecting at ground level. We recommend that the main cable and fixing security is thoroughly inspected at least in accordance with the manufacturers recommendations to check for damage, security or internal rusting, this will help to ensure the continued safe use of the equipment

Action: Inspect in accordance with the manufacturers recommendations

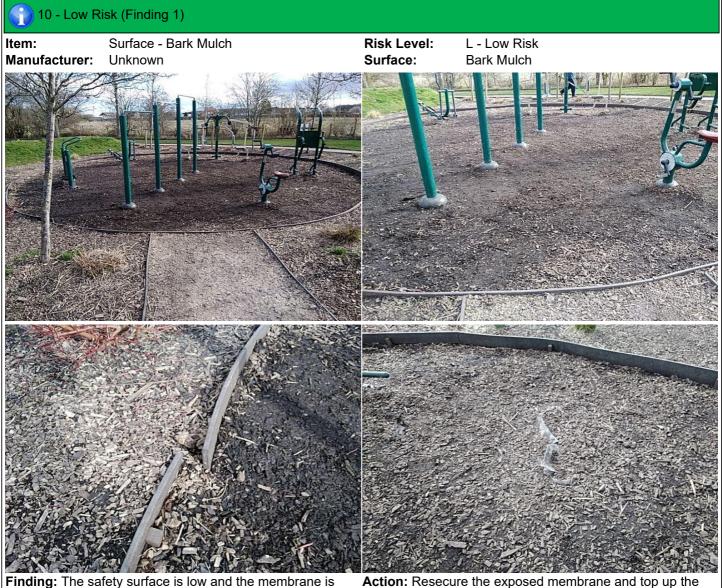
The safety surface is low and the membrane is exposed also loose edging is creating trip points - Resecure the exposed membrane and top up the surface to the correct level repair edging

exposed also loose edging is creating trip points

Action: Resecure the exposed membrane and top up the surface to the correct level repair edging
