# **Annual Inspection**

**Croston Parish Council**

Croston Rec Play & Gym Areas

Inspected: 12-March-2025 - 09:17 by Michael Allbright

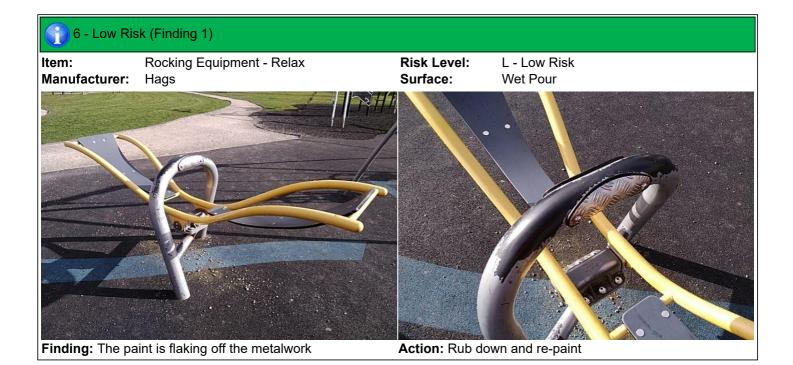
Finding: A number of fixing(s) are missing missing or loose, Action: Replace/Secure all loose fixings and treat/paint unit metalwork (Hazard tape applied customer on site made aware DO NOT ALLOW USE UNTIL REPAIRED)

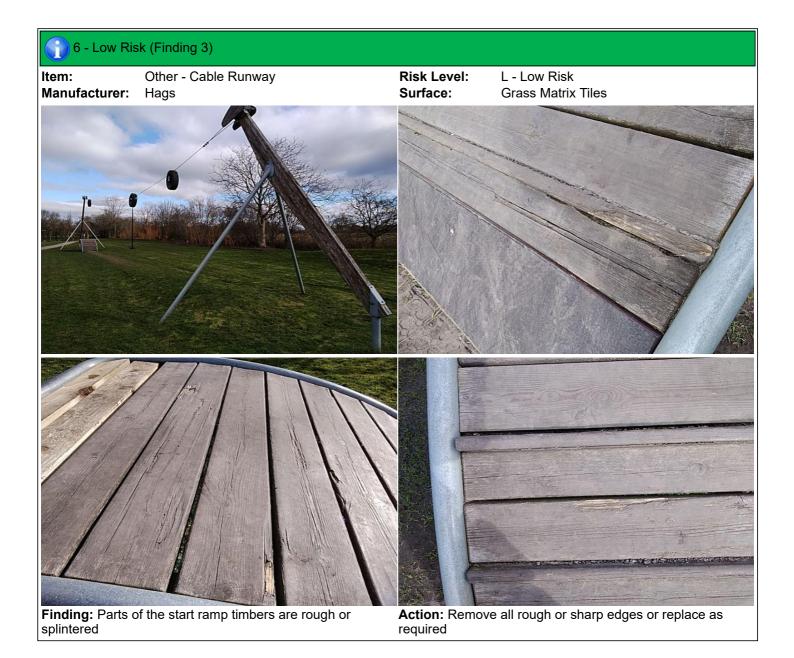
8 - Low Risk		
Item:	Cable Runway	
Manufacturer:	Hags	
Surface Type:	Grass Matrix Tiles	
Item Quantity:	1	
Equipment Compliance:	N/A	and the second
Surface Area Compliance:	N/A	
Total Findings:	3	
Finding 1		Finding 2
There is algae on the surface treat appropriately	e of the equipment - Clean and	We have completed a visual inspection of the cable and fixing points from ground level, however it is not possible to fully inspect the cable and fixings without either hiring equipment to gain access or removing the cable and inspecting at ground level. We recommend that the main cable and fixing security is thoroughly inspected at least in accordance with the manufacturers recommendations to check for damage, security or internal rusting, this will help to ensure the continued safe use of the equipment - Inspect in accordance with the manufacturers recommendations

Action: Inspect in accordance with the manufacturers recommendations
